Orbital Transfer Vehicle Oxygen Turbopump Technology

Final Report, Volume II—Nitrogen and Ambient Oxygen Testing

R.J. Brannam, P.S. Buckmann, B.H. Chen,
S.J. Church, and R.L. Sabiers
GENCORP Aerojet TechSystems
Sacramento, California

December 1990

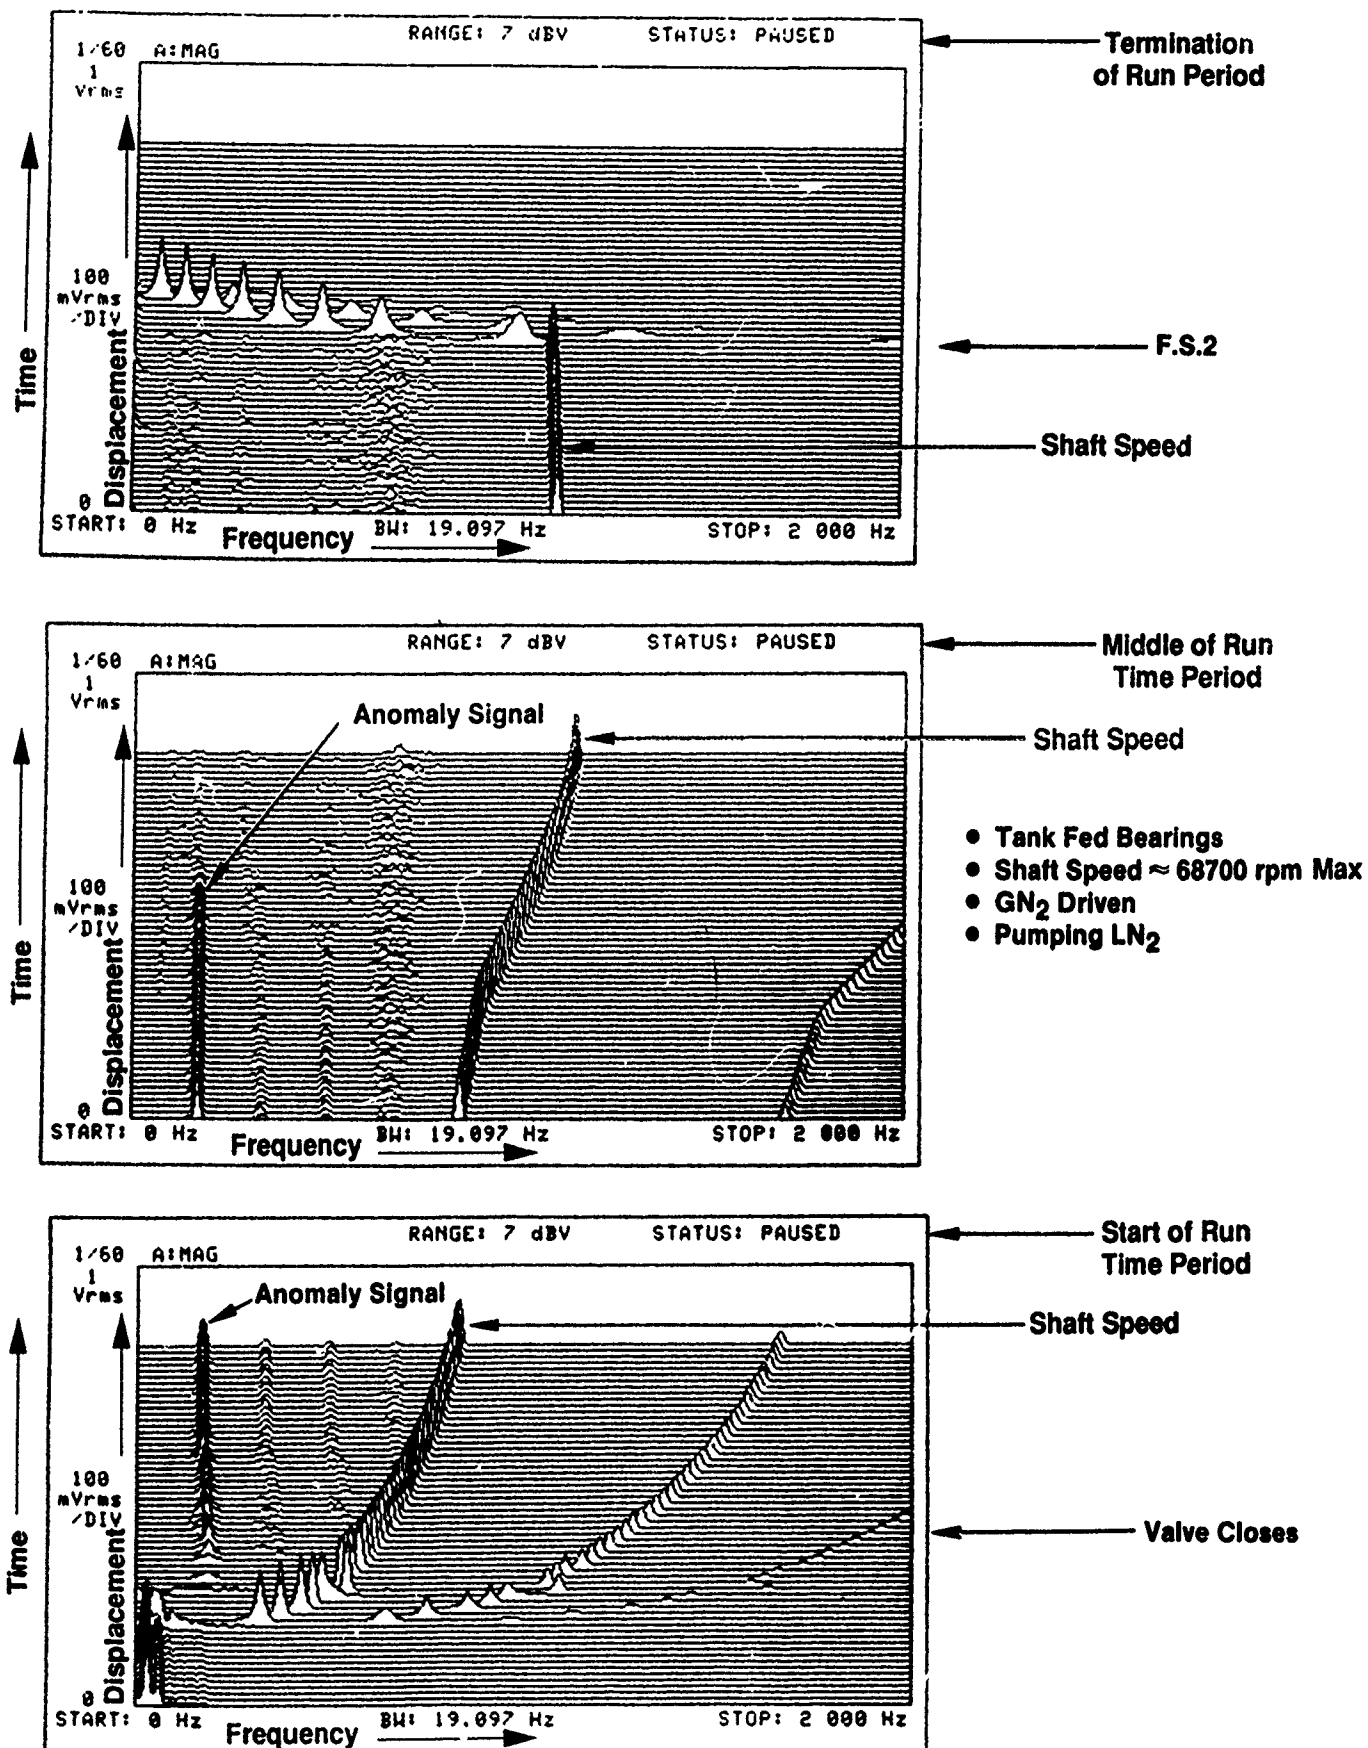
Figure 3.1-1. "Waterfall" Plot for Test 133 Probe Signal NT-Z

During these test series the turbopump operated with an apparent cyclic axial shaft motion. This anomaly was detected by the axial distance probe and was basically undetected in the radial "Y" distance detector with only a small response in the axial "Z" direction. This axial motion was characterized by a constant frequency of approximately 10,000 cpm. The amplitude was also constant at approximately ±.0005 in. "Waterfall" plots of the axial distance detector for two typical tests are given in Figure 3.1-1 and Figure 3.1-2. The liquid nitrogen pumping test, Figure 3.1-1, used a separate pressurized tank to feed the bearings. The second plot documents the same phenomenon extending right up to the last revolution (see the time line marked F.S.2, fireswitch two) at the termination of the run period (the top time vs frequency plot, Figure 3.1-2).

The predominant displacement peak starting at zero progressing upwards to the right is the shaft speed signal with the amplitude derived from the .002 inch step at the end of the shaft. The vertical predominant peak is the 10,000 cpm frequency (~170 Hz) axial displacement and anomaly. Figure 3.1-1 shows the tank fed bearing system operating with liquid nitrogen. Figure 3.1-2 illustrates the pump fed bearing system operating with LOX showing the same phenomena.

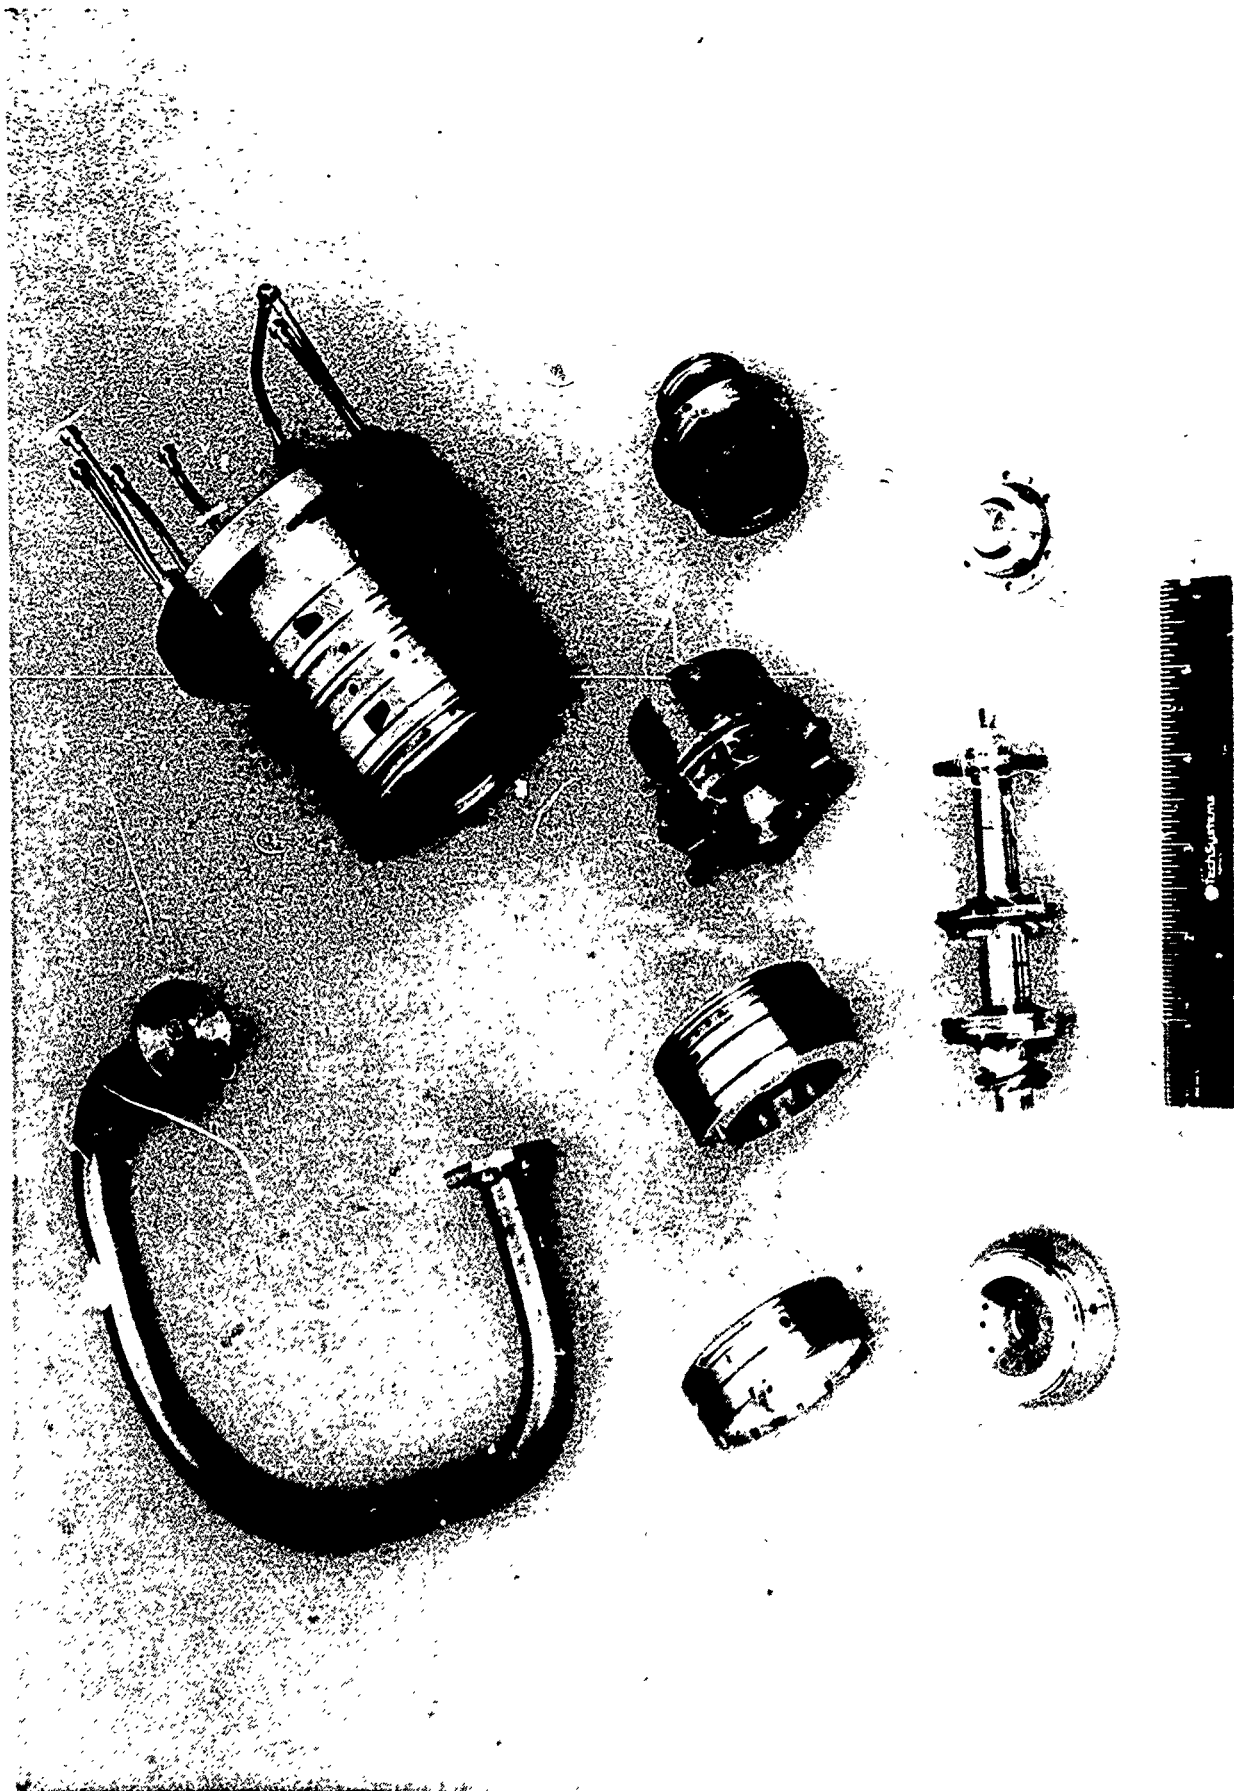
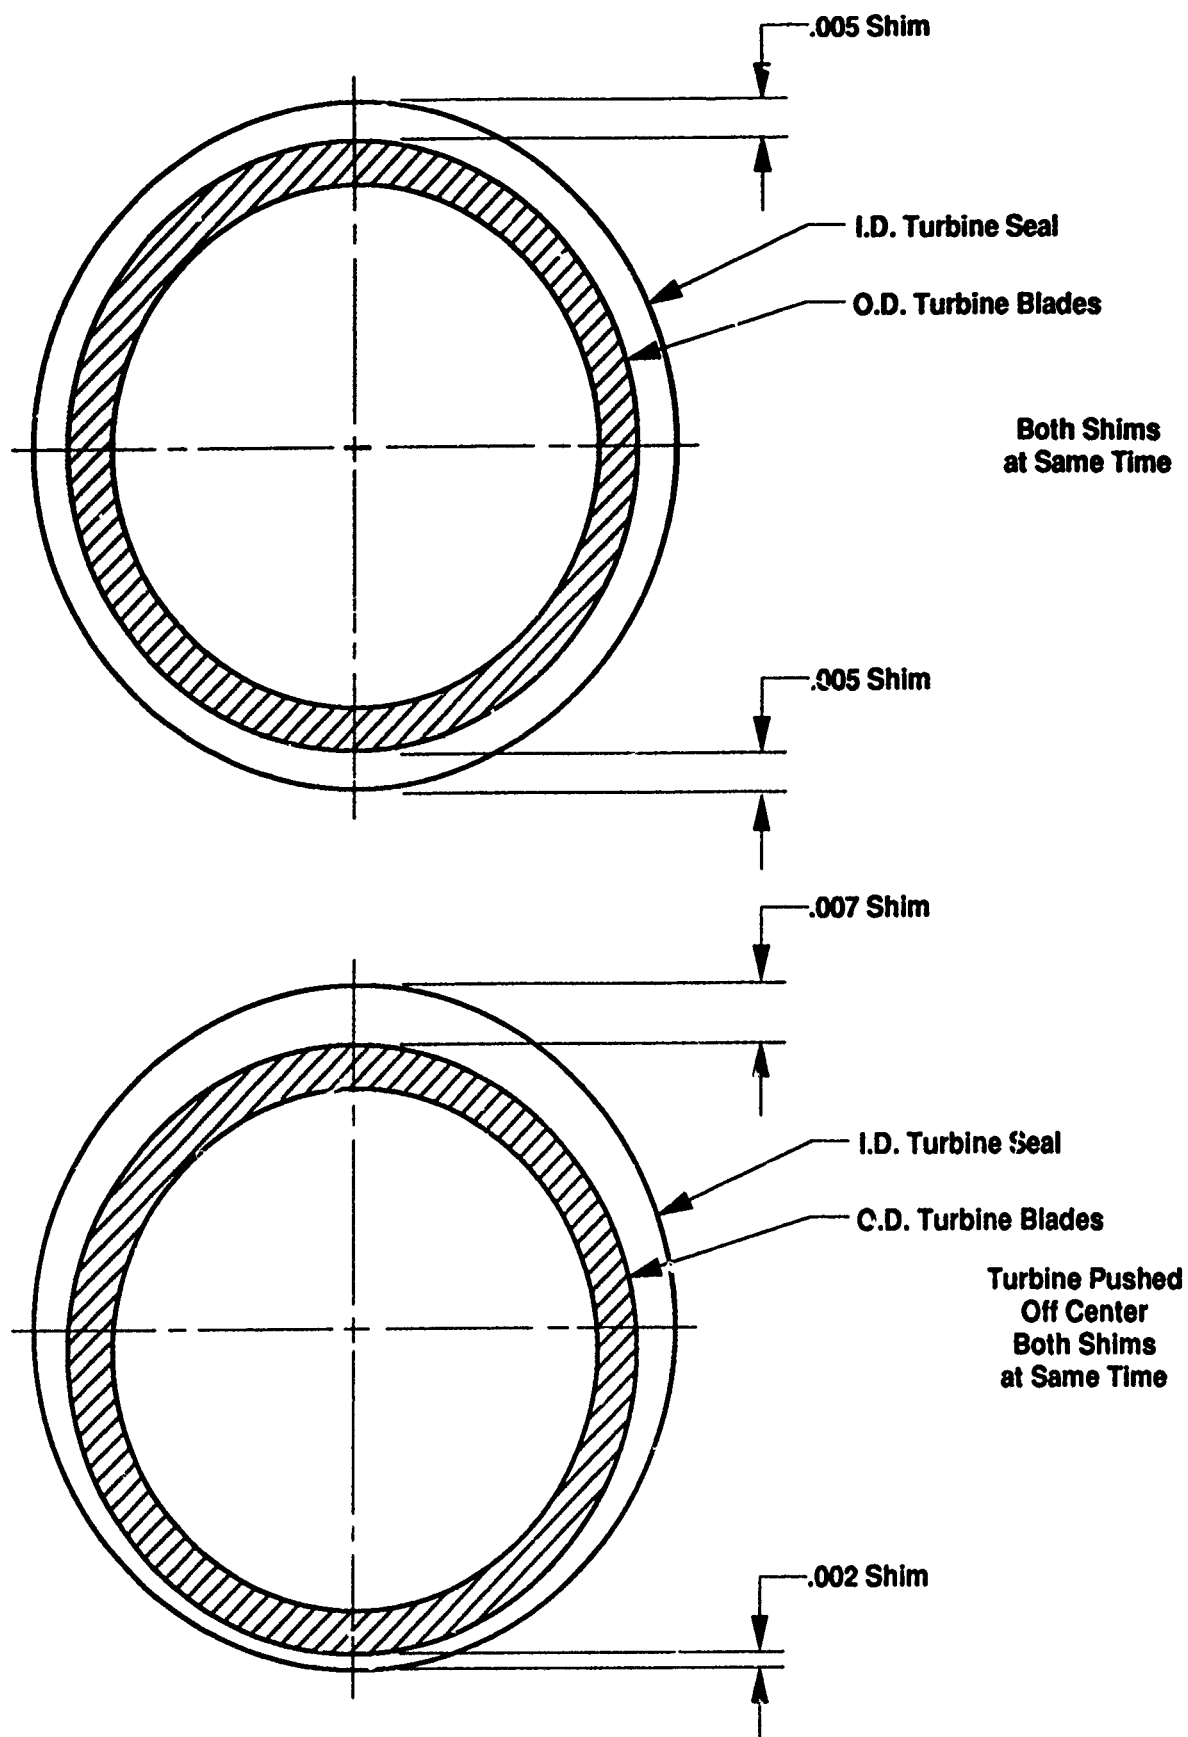
Figure 3.5-1. Turbine Tip Clearance Check

Turbine Pushed
Off Center
Both Shims

at Same Time

.002 Shim

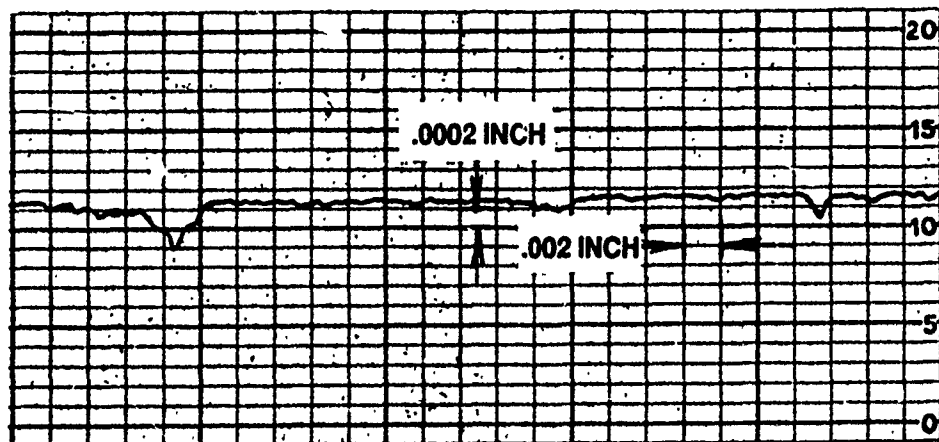
Figure 3.5-7. Profile of Turbine Bearing Journal Surface Along Shaft Axis

During these start transients the axial distance detector indicated non-contact rotation after approximately 10 revolutions. The speed at this time was in the range of 15,000 rpm. During the test series D and E1 which were LOX/GN$_2$ and LOX/GOX tests, respectively, 14 unassisted start/stop transients were performed. The axial thrust bearing condition on teardown after the entire test series was excellent. The journal bearings had some wear which was diagnosed as occurring during the initial rotation tests in LN$_2$.

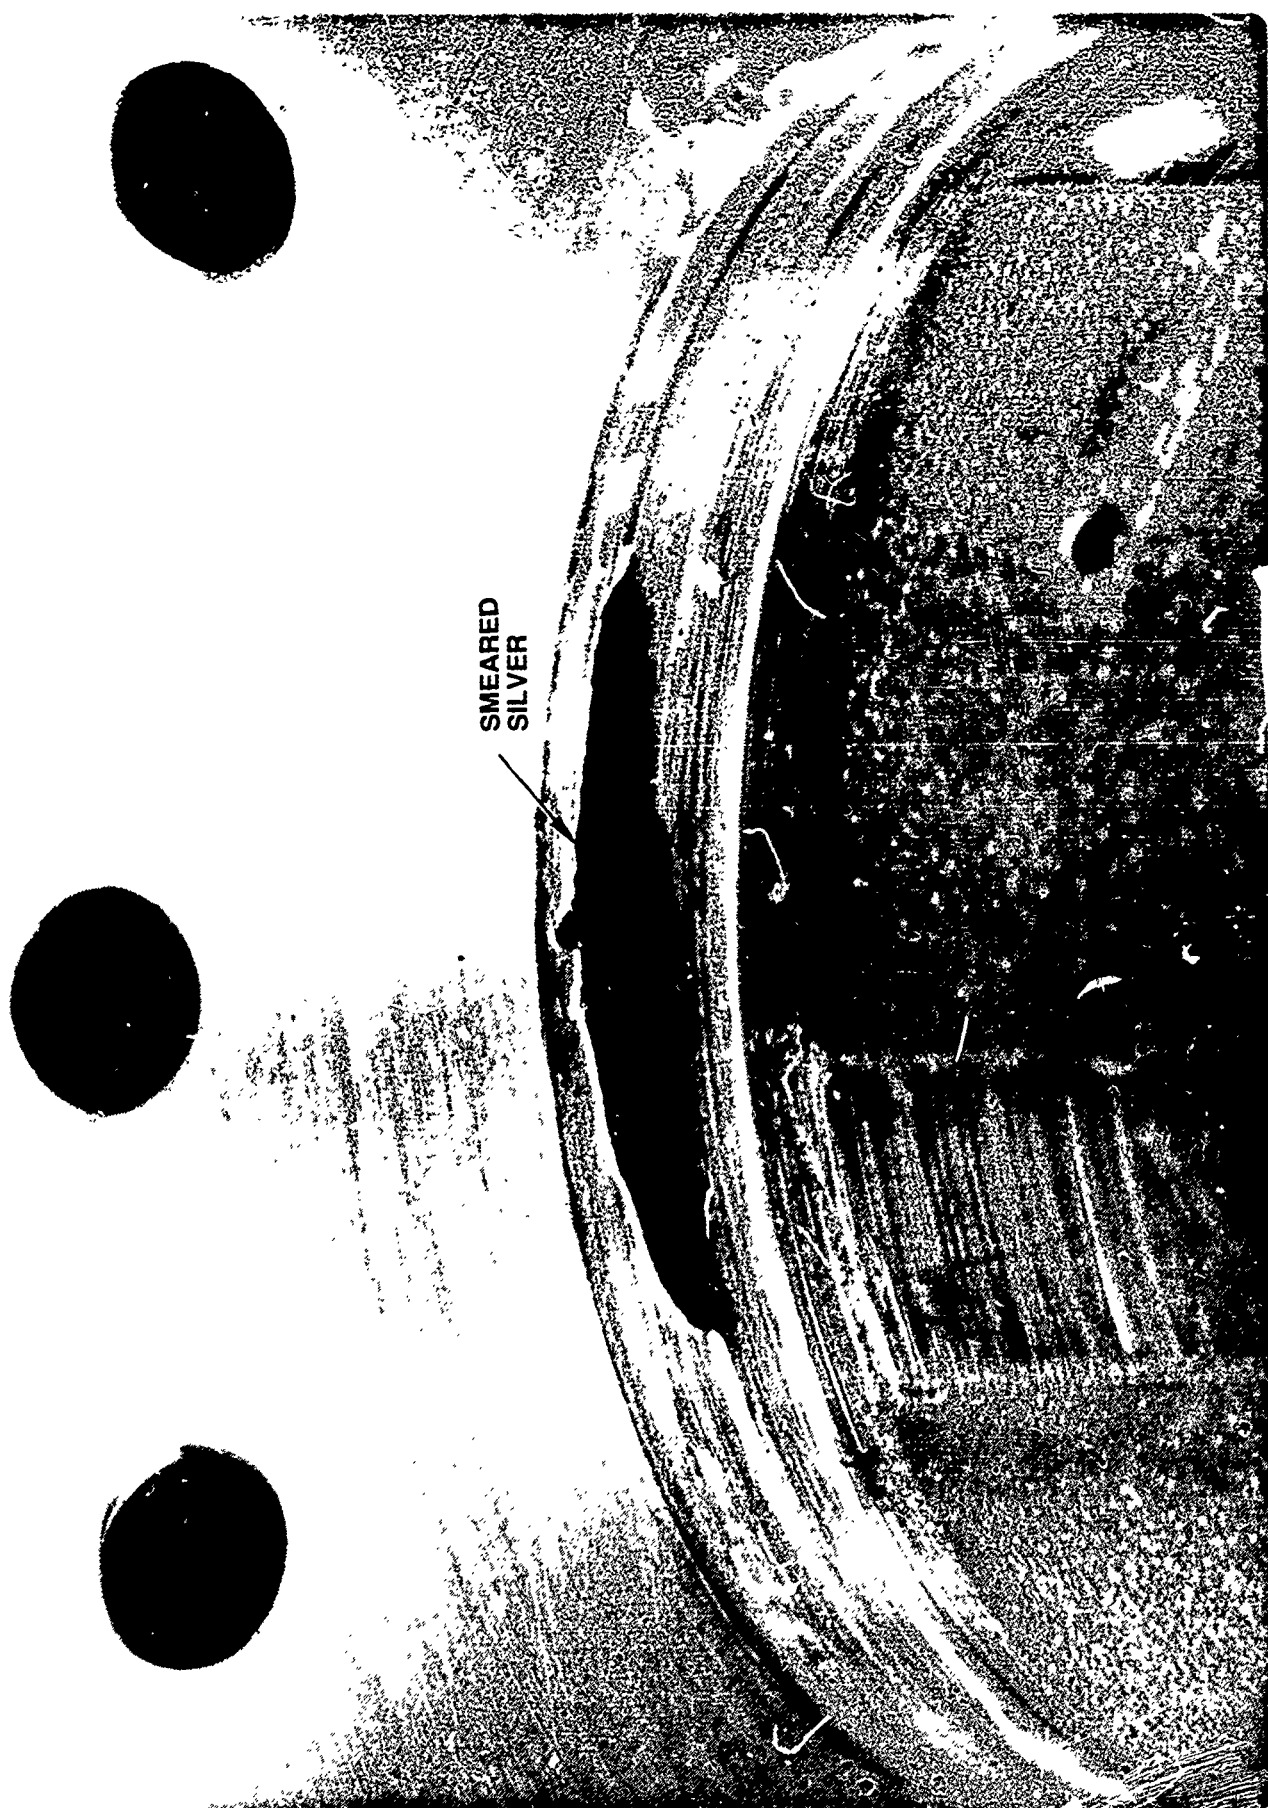
Figure 3.5-14. Pump Bearing Bore View Looking From the First Stage Impeller Side

SMEARED
SILVER

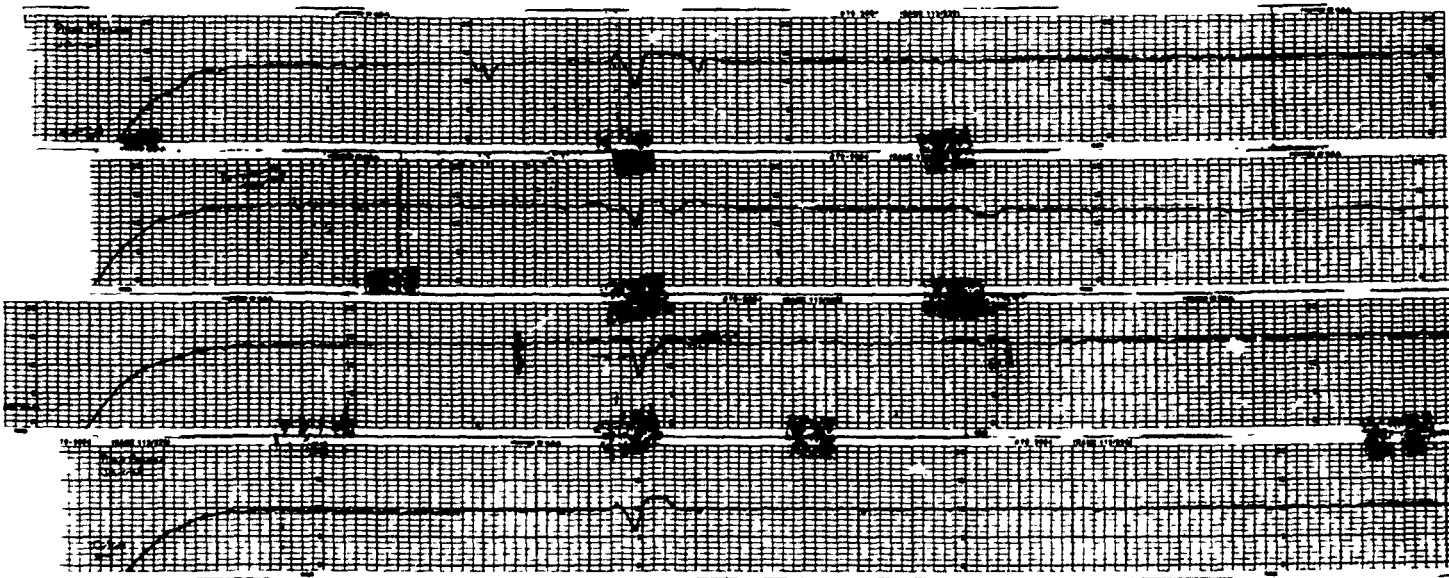
Figure 3.5-16. Pump Bearing Journal Profile

Note: The Four Axial Profiles Represent Surfaces at
90° Circumferential Between Pockets

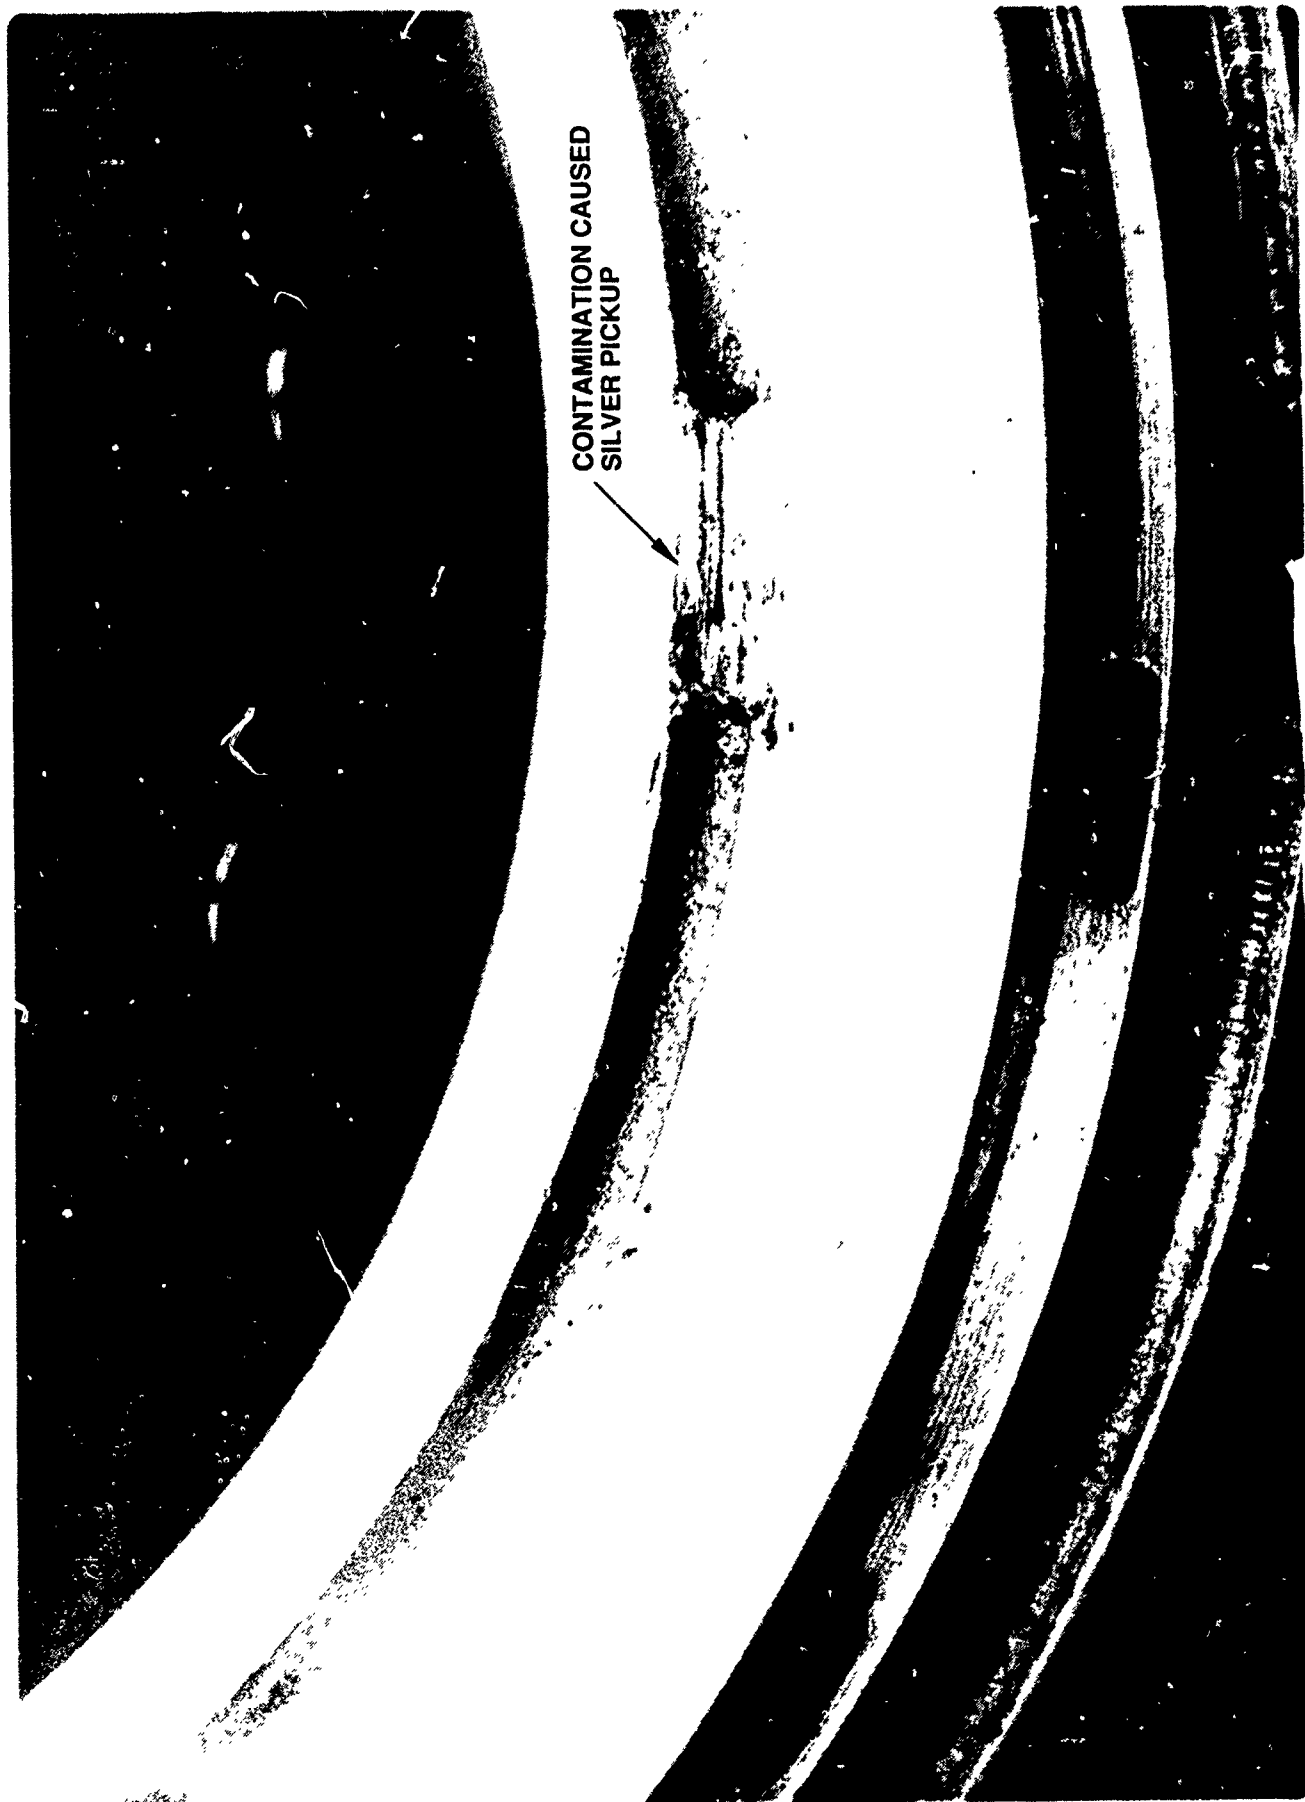
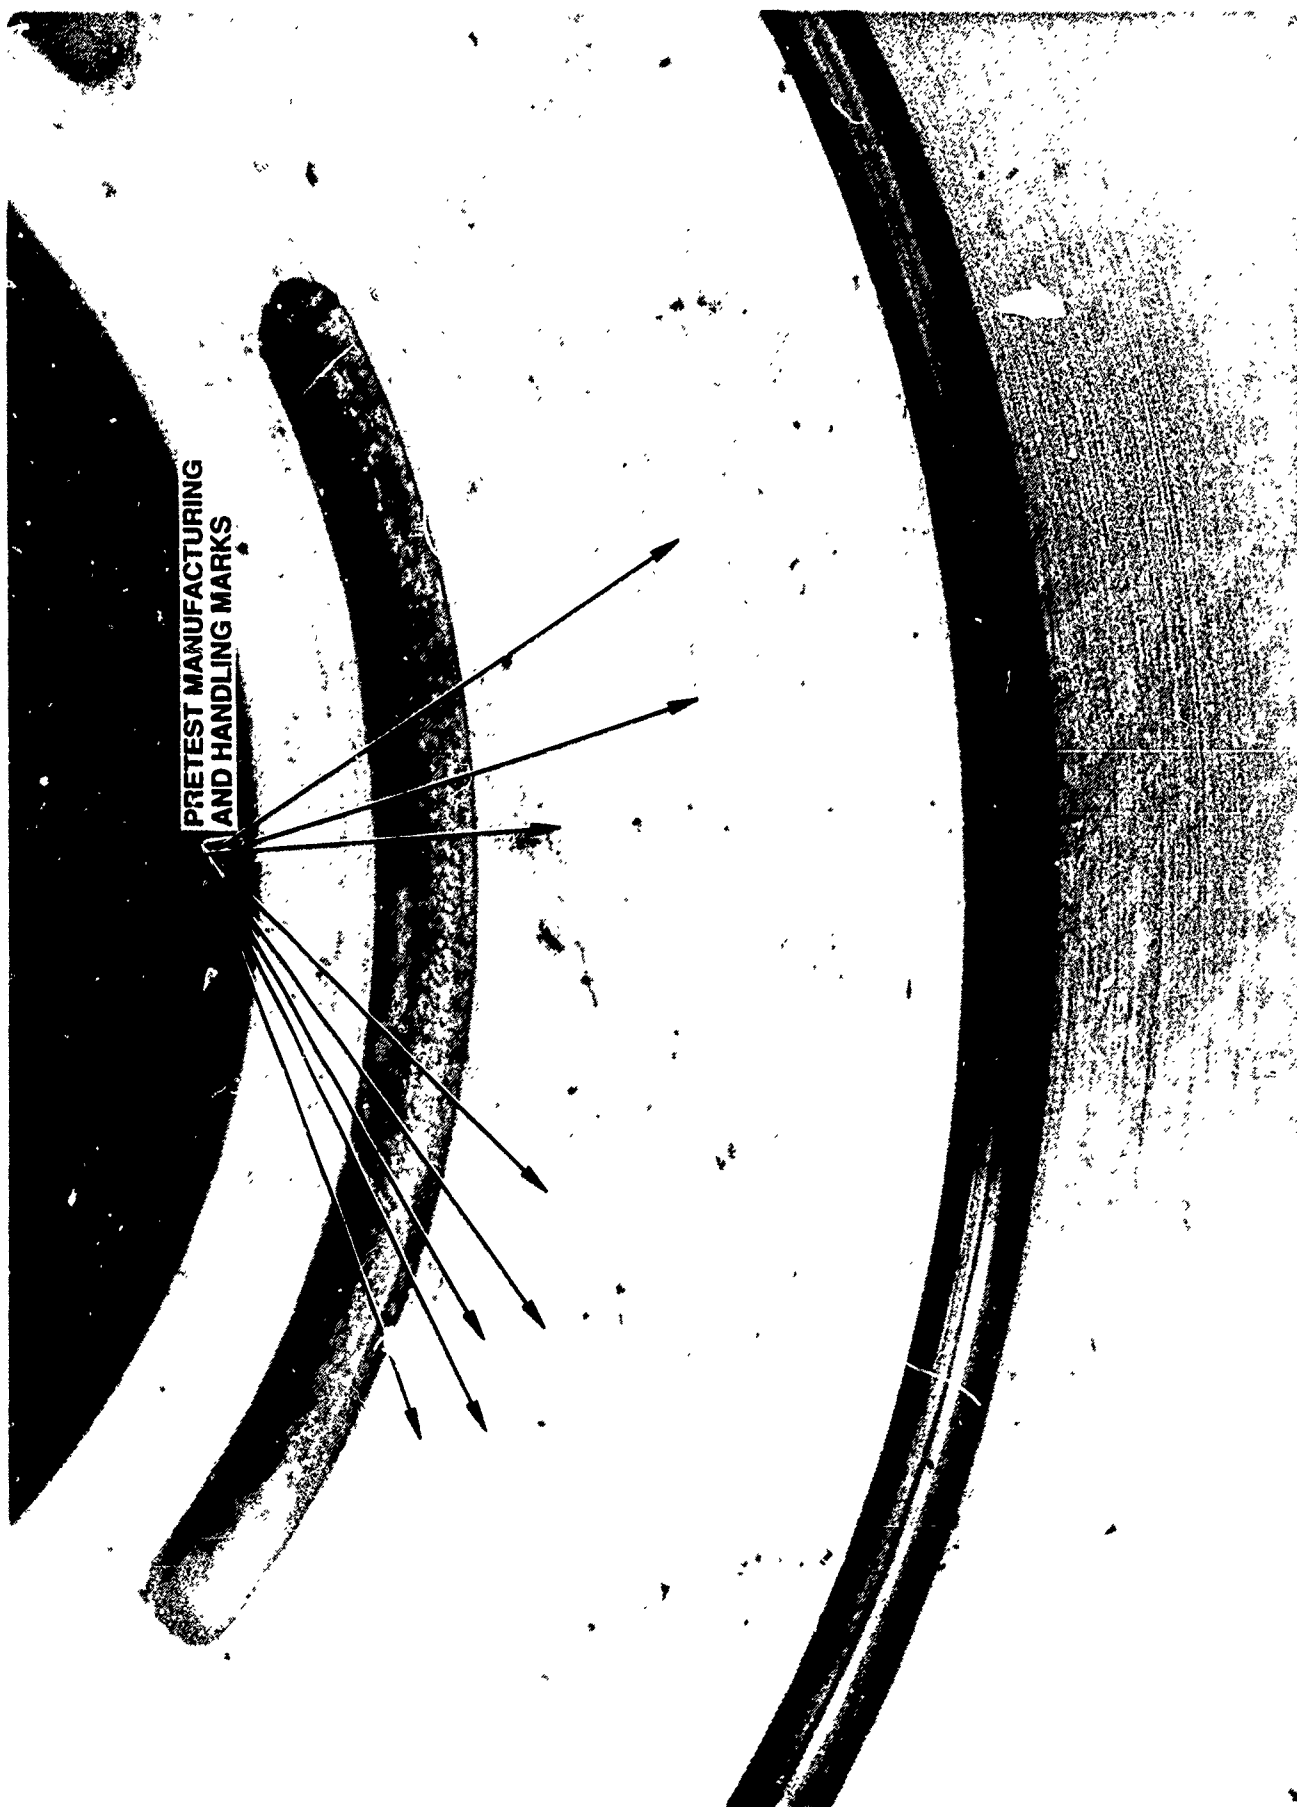
CONTAMINATION CAUSED SILVER PICKUP

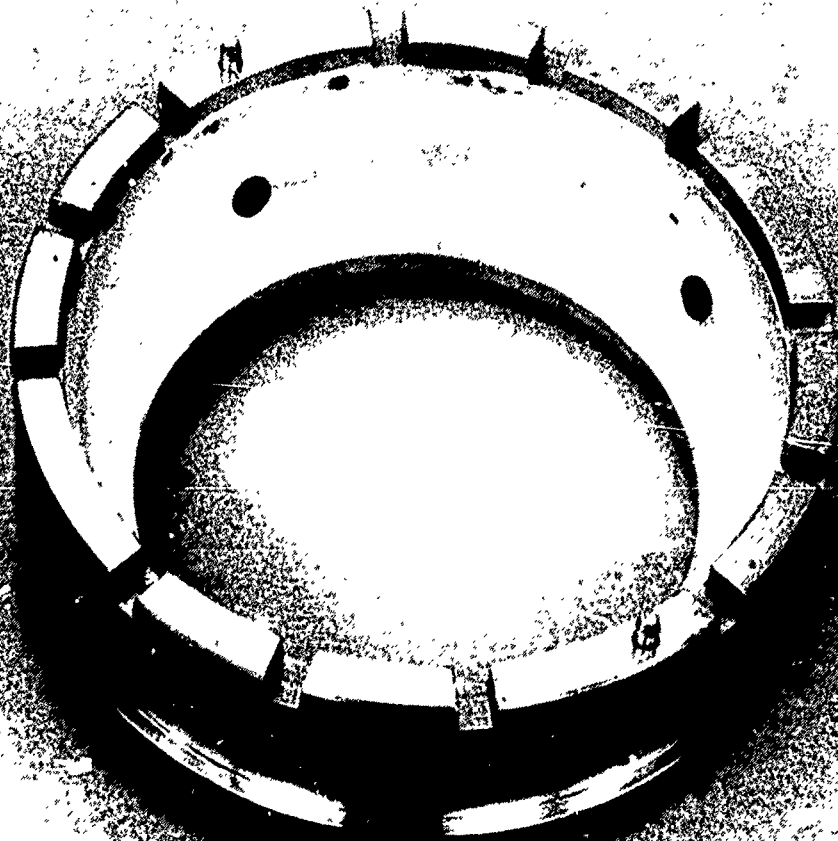
Figure 3.5-18. Second Stage Thrust Bearing Surface Post Test

The thrust bearings provided high axial load support, high pressure impeller sealing, high axial stiffness, and unassisted lift-off during start and stop transients. The bearings were operated to high pressures subjecting the rotating assembly to high axial forces. Typical calculated nominal net axial loads were approximately 150 lb. The absolute loads on each impeller disk are quite high on the order of 5000 lb. The thrust bearing axial capacity is shown in Figure 3.4-5 for the design pressure differential. The bearing capacity is a direct ratio of this pressure differential which is determined by pump speed. The first thrust bearing sealing pressure differential was 962 lb/in.^{2} while the bearing orifice supply pressure differential was 2612 lb/in.^{2} ($P_{PBI}-P_{BE}$). Axial motion of the shaft at a low constant frequency existed (displacement probe output signal) during this test series. It obviously loaded the thrust bearing. Thrust cyclic excursions were in the range of $\pm.0005$ in. This requires several hundreds of pounds cyclic axial load to produce this motion. Even with this adverse loading situation the thrust bearing maintained adequate impeller vane clearance and thrust bearing clearance. The calculated thrust bearing load during the unassisted "start transient" started at 24 lb on the first stage thrust bearing. This load definitely created metal-to-metal contact initially. Fourteen unassisted starts were performed in LOX. The thrust bearings were found to be in excellent condition posttest.

PRETEST MANUFACTURING
AND HANDLING MARKS

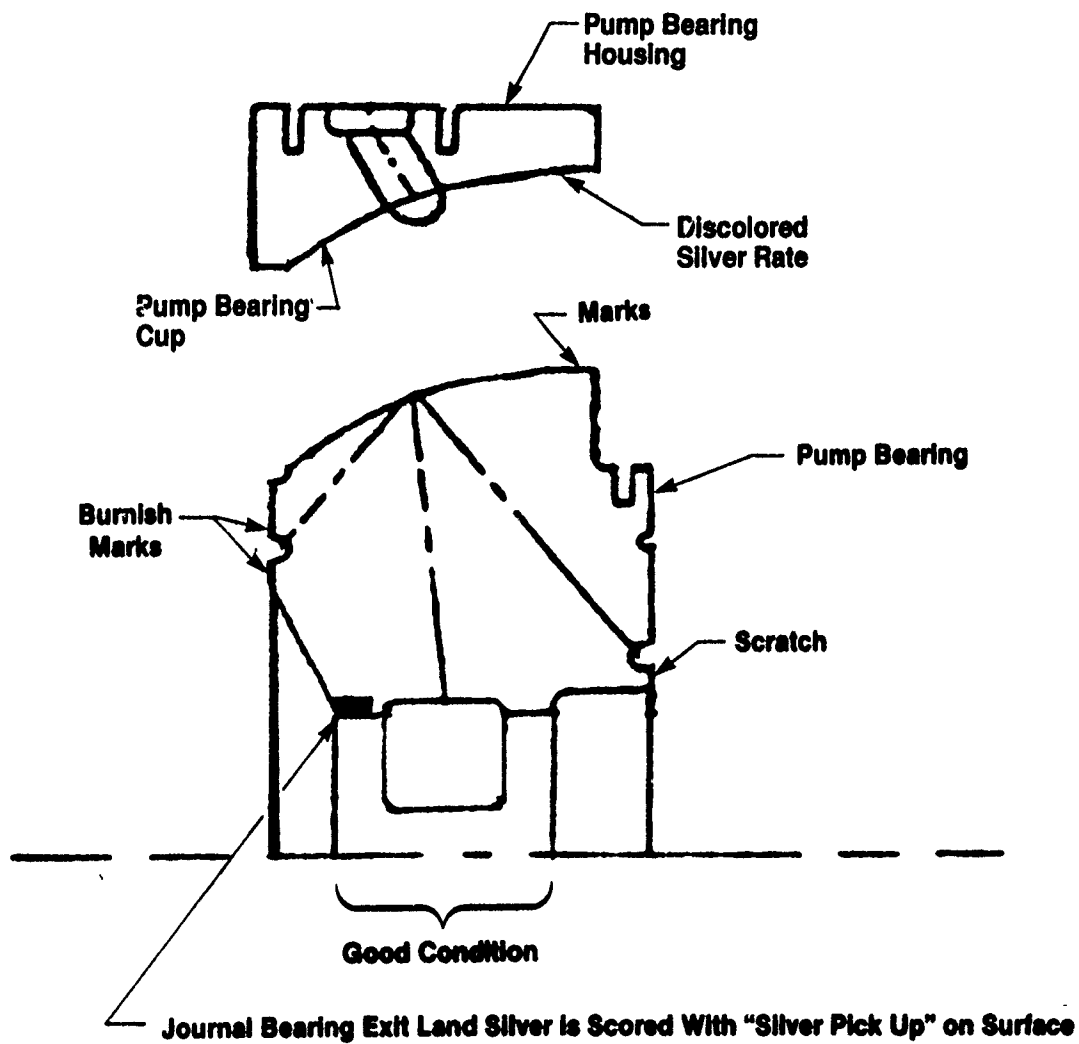
Figure 3.5-20. Pump Bearing Housing Cup Silver Surface

DISCOLORED
SILVER PLATE

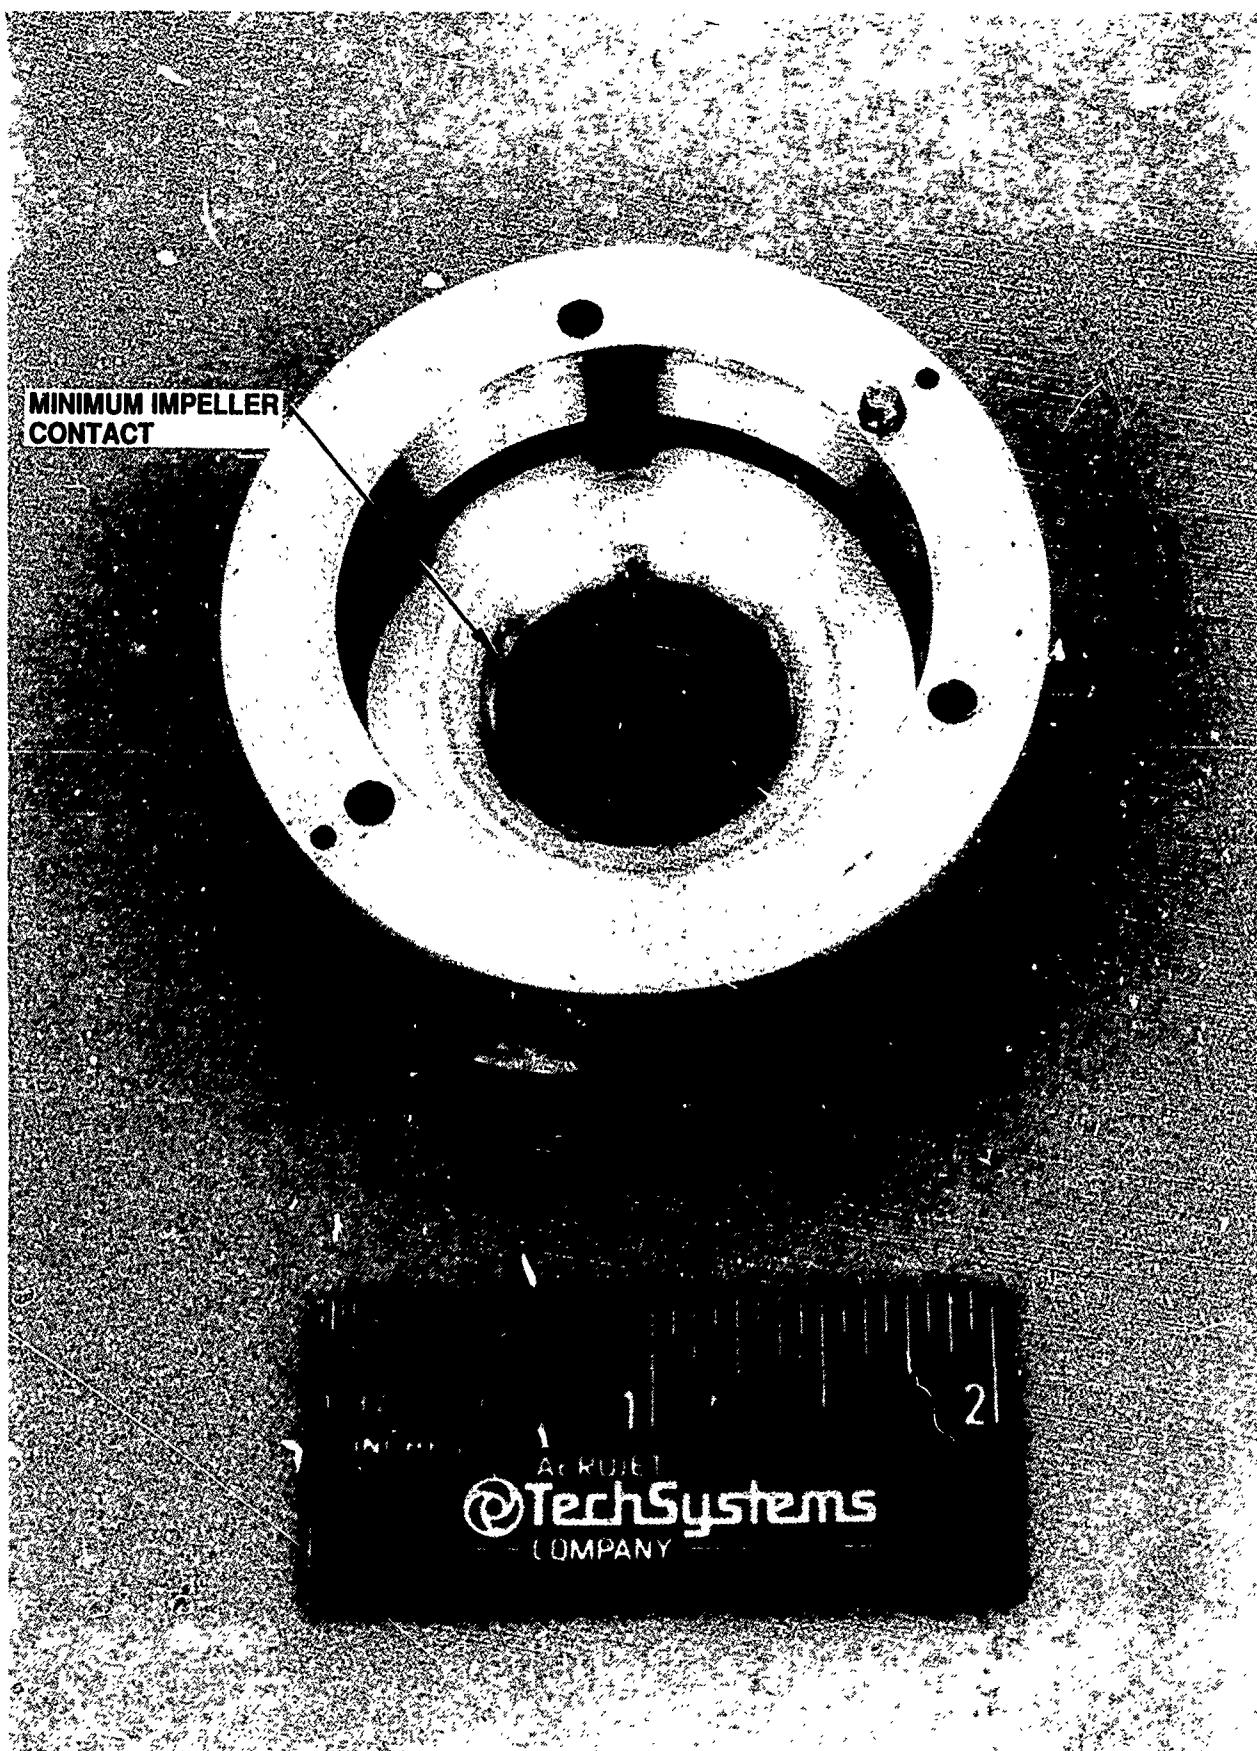
**Figure 3.5-22. Second Stage Impeller Housing**

The second stage impeller housing shown in Figure 3.5-22, is in excellent condition. Two things were found on this part. First, there was slight trace of discoloration in the pump inlet and a small amount in the bearing area. This substance was a very thin tan powder (oxidation?). There was the same substance in the first stage diffuser passage but not in the crossover passages. Second, a small amount of impeller vane contact on the silver housing contour was experienced. This minute contact is shown close up in Figure 3.5-23. This contact occurred where the radial surface of the impeller housing contour enters the housing inner radius. This was the point of minimum clearance during the turbopump assembly and probably contacted during assembly.

MINIMUM IMPELLER CONTACT

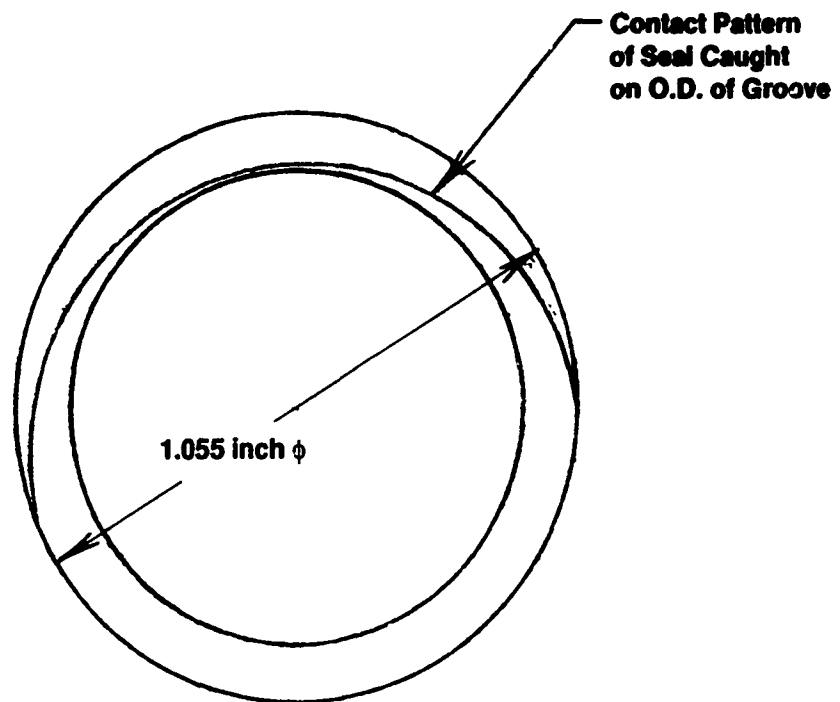
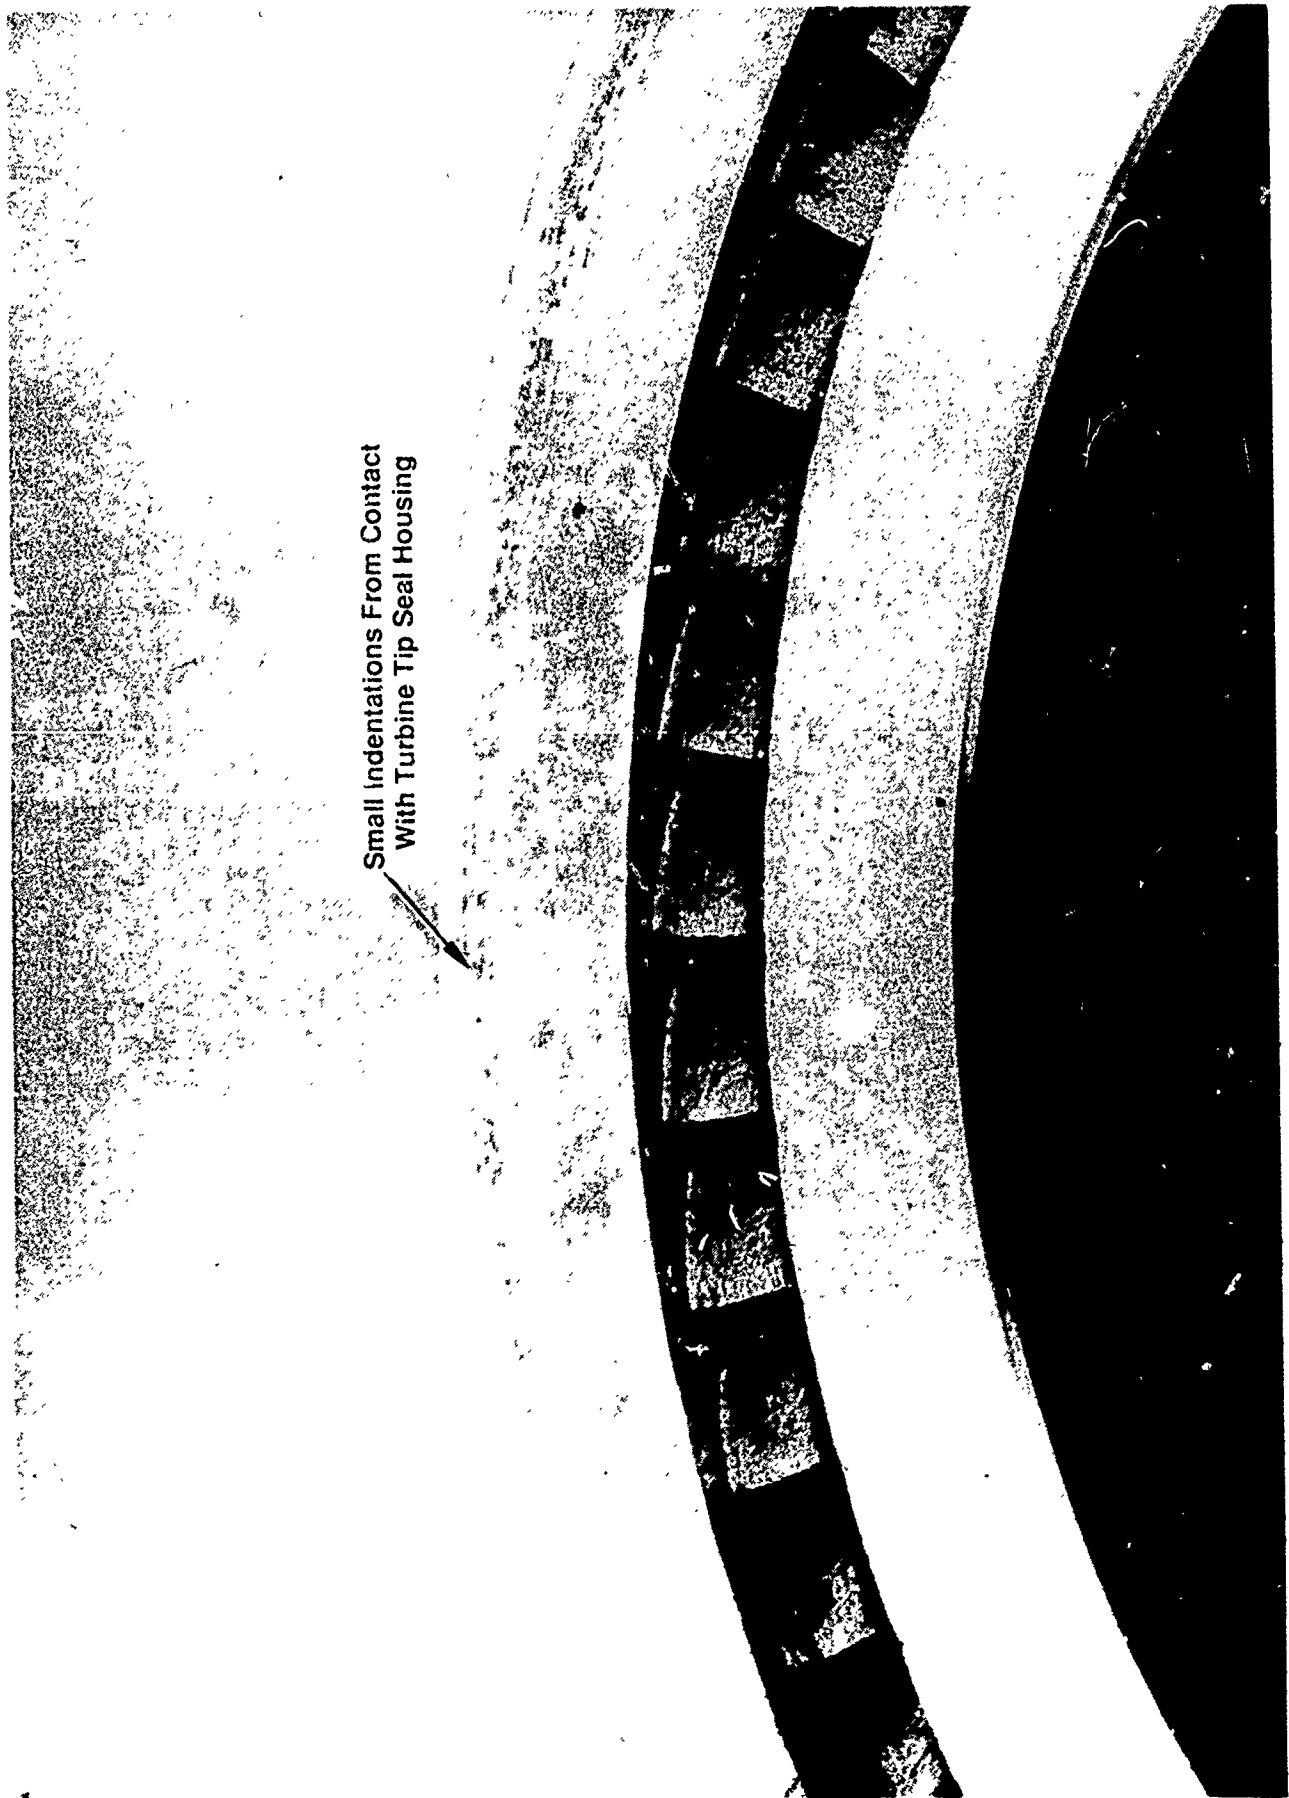
Contact Pattern

of Seal Caught
on O.D. of Groove
